DOT HS 808 220

June 1994

# **Final Report of a 1991 Chevrolet Silverado into a 50% Left Offset Barrier in Support of CRASH3 Damage Algorithm Reformulation**

The purpose of the five (5) 50% left frontal offset barrier impact tests was for research and development in support of the CRASH3 damage algorithm reformulation.

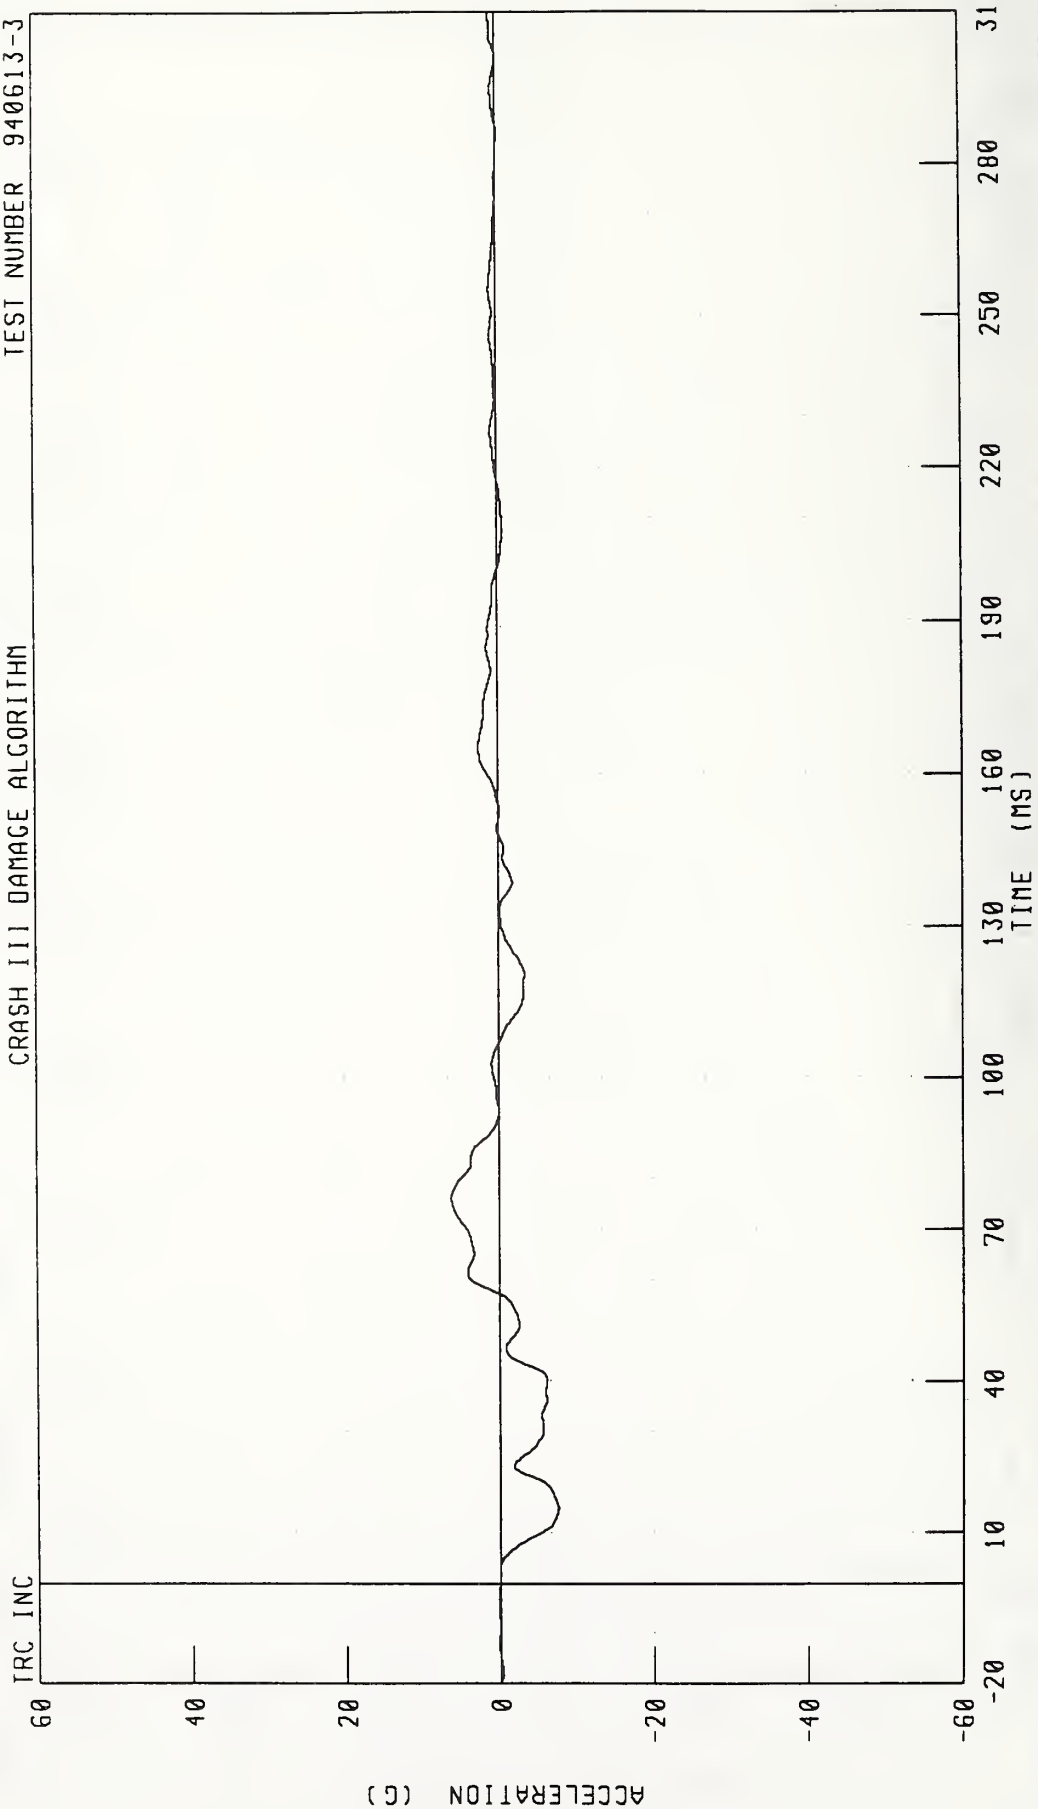
CRASH III DAMAGE ALGORITHM TEST NUMBER 940613-3

RIGHT REAR SILL Y-AXIS ACCELERATION

CHANNEL RRSYG1 FILTER CH CLASS 60 PEAK DATA 6 24 G @ 76.32 MS; -7.53 G @ 14.88 MS

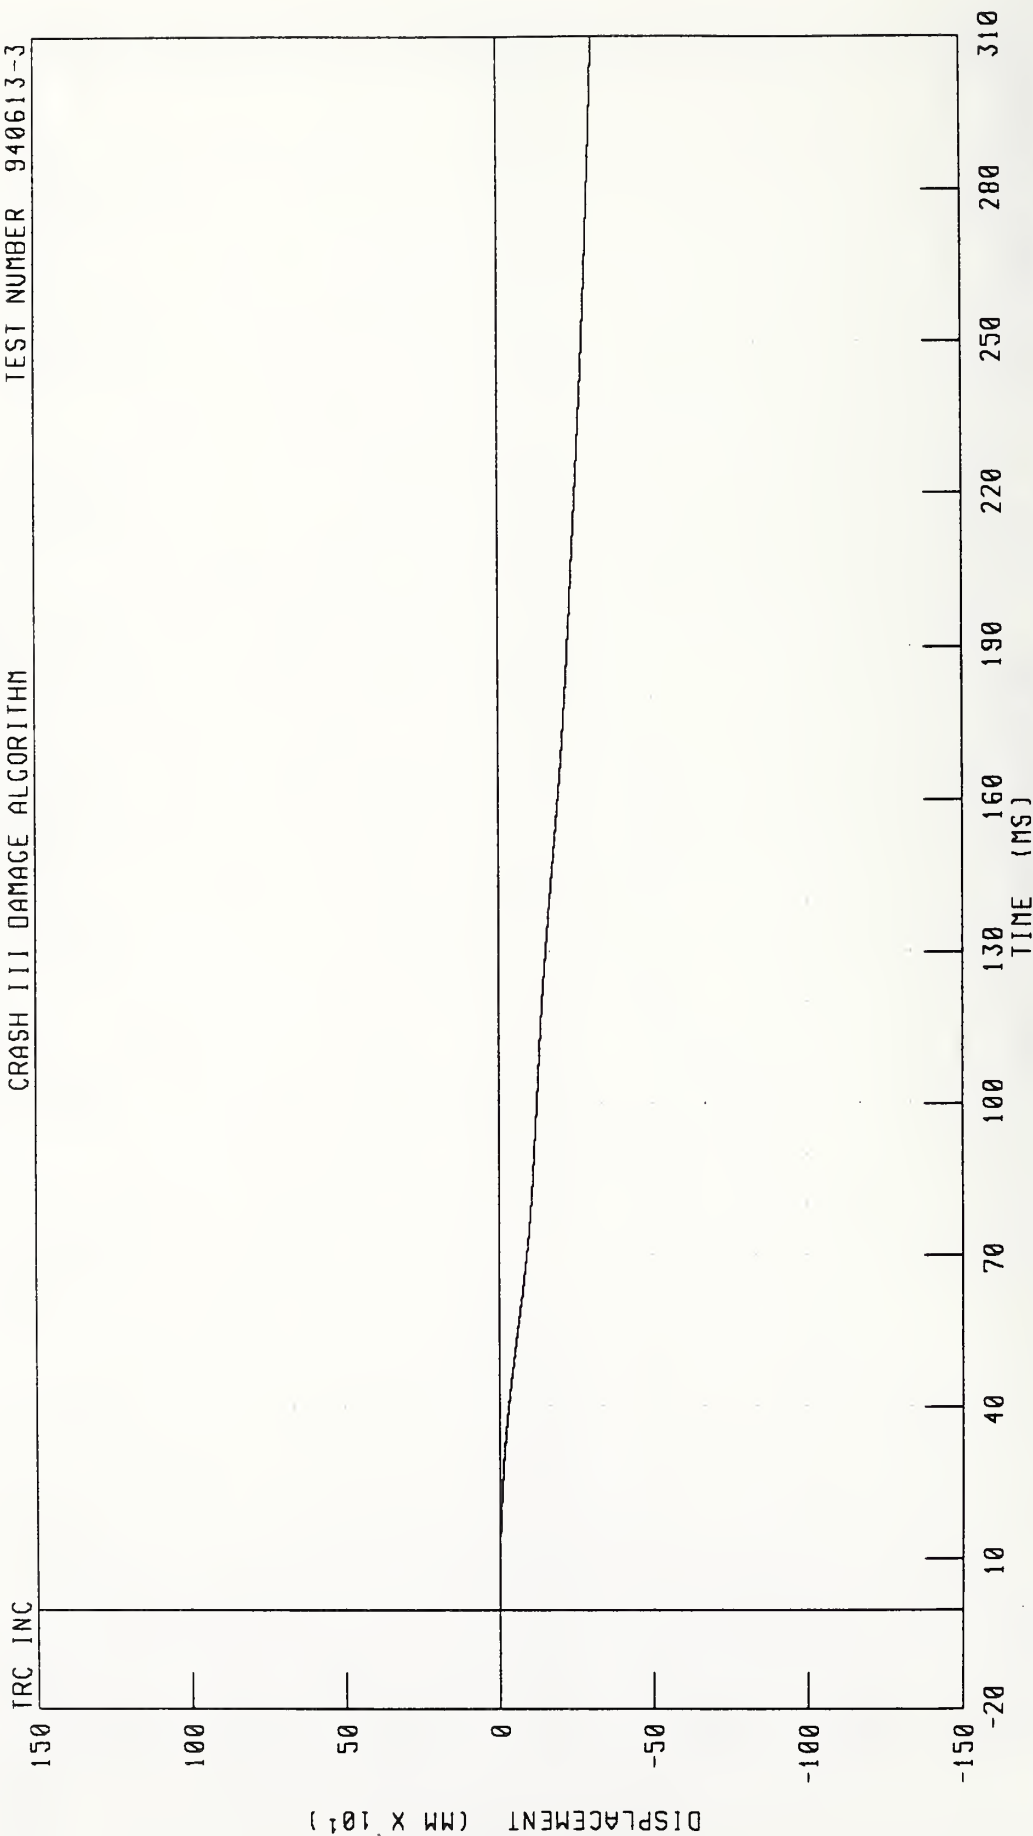
CRASH III DAMAGE ALGORITHM TEST NUMBER 940613-3

RIGHT REAR SILL Y-AXIS DISPLACEMENT

CHANNEL RRSY01 FILTER: CH CLASS 180 PEAK DATA 0 00 MM @ 0 00 MS, -309 68 MM @ 310 00 MS

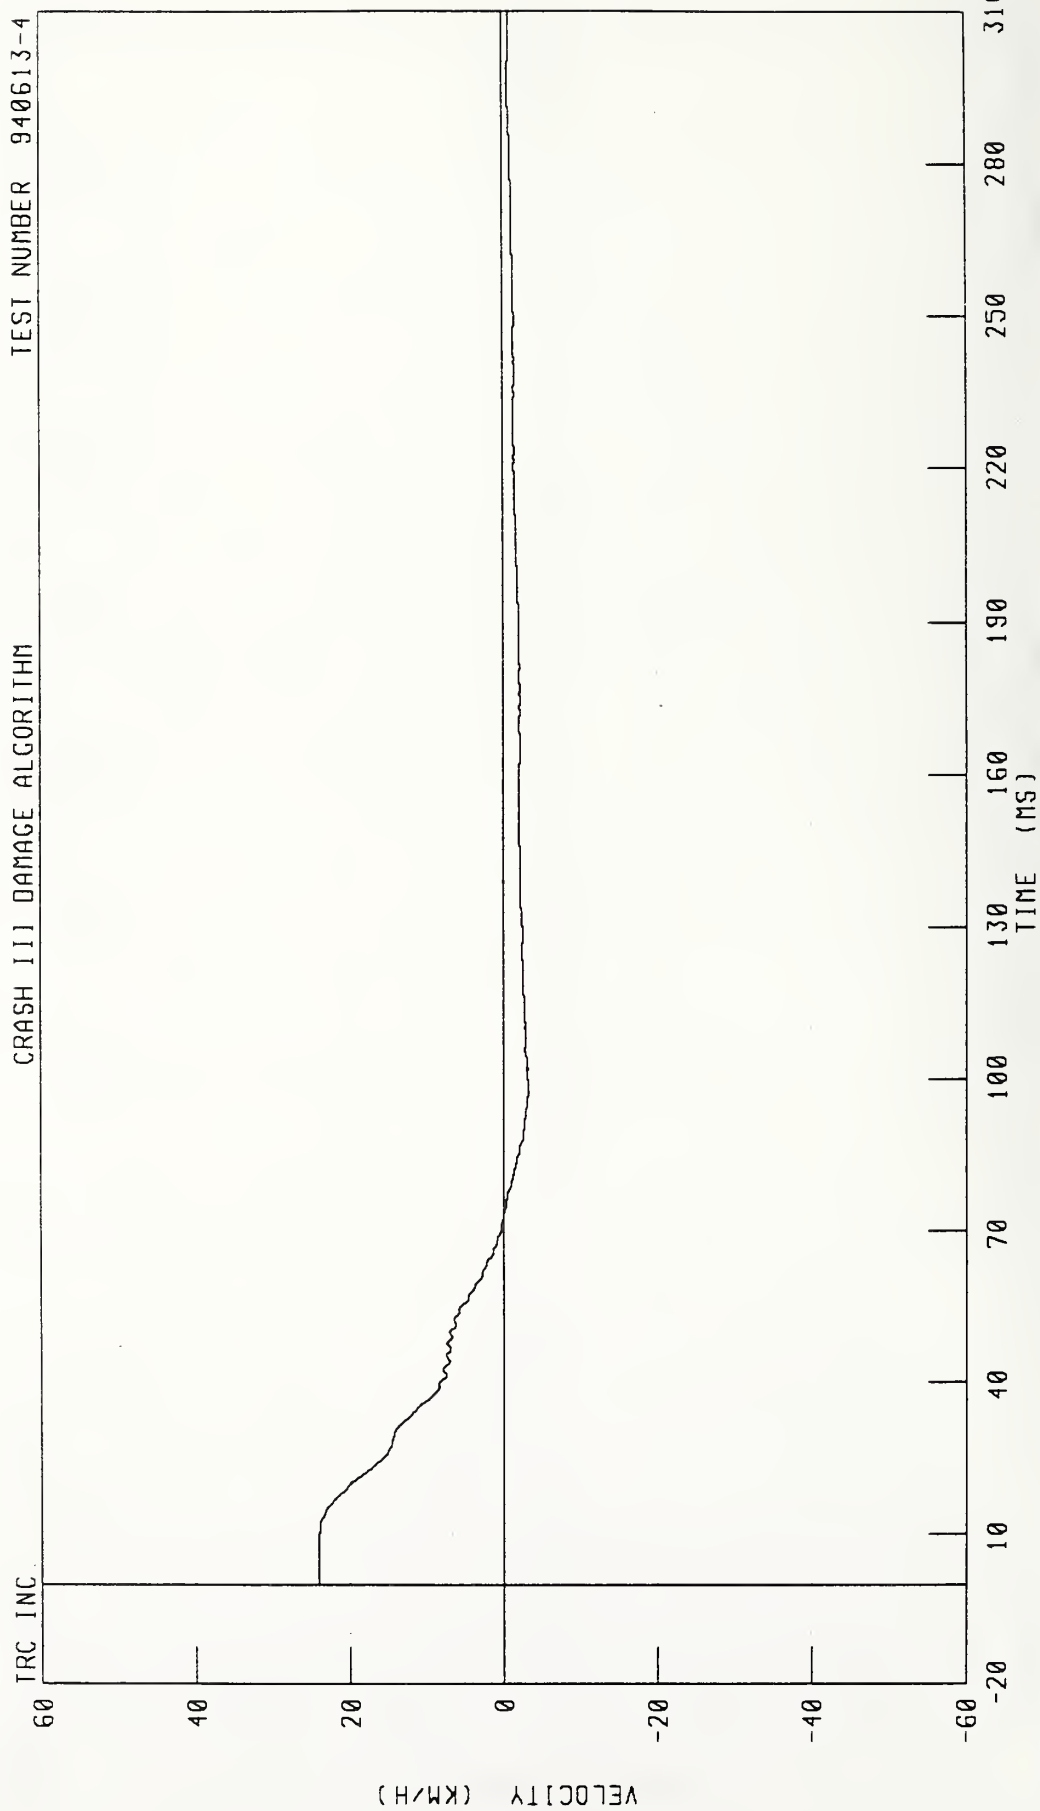
TEST NUMBER 940613-4

CHANNEL VCGXV1 FILTER CH CLASS 180

PEAK DATA 24 10 KM/H @ 0 00 MS, -3 24 KM/H @ 97 52 MS

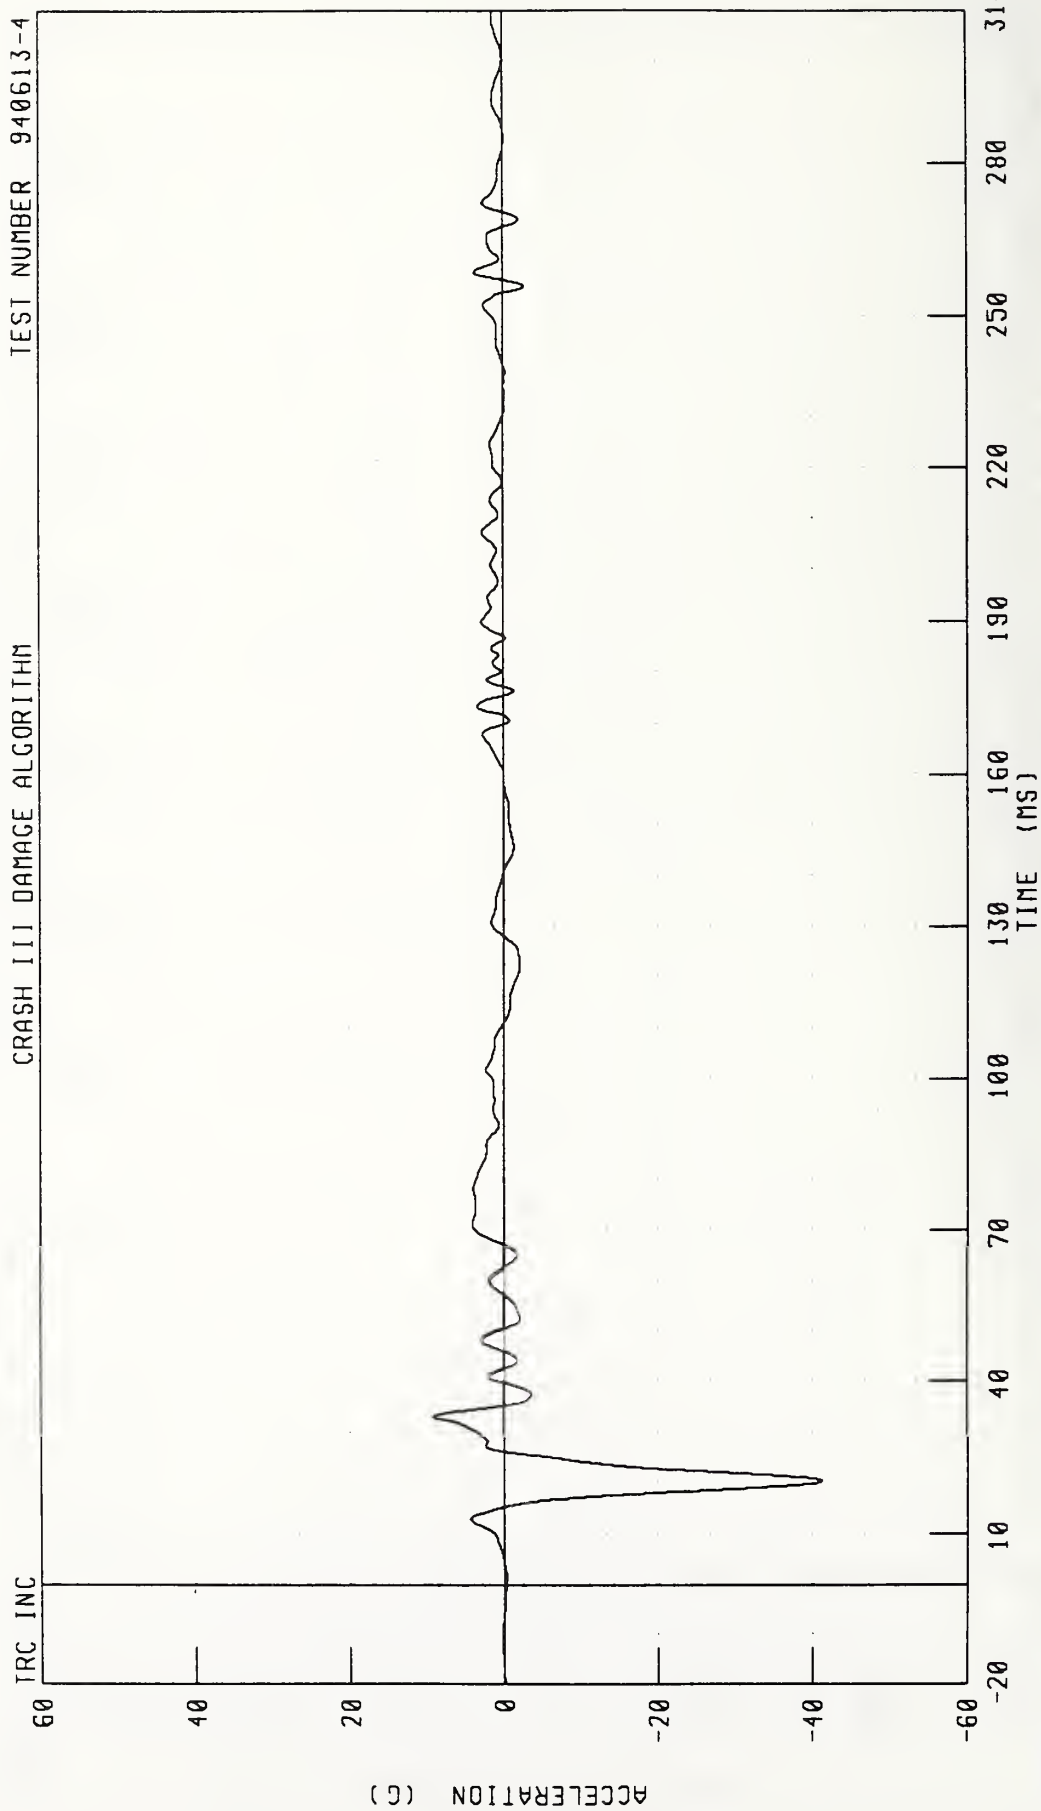
TEST NUMBER 940613-4

CHANNEL: VCGY61 FILTER: CH CLASS 60

PEAK DATA: 9 18 G @ 33 12 MS, -41 14 G @ 20 48 MS

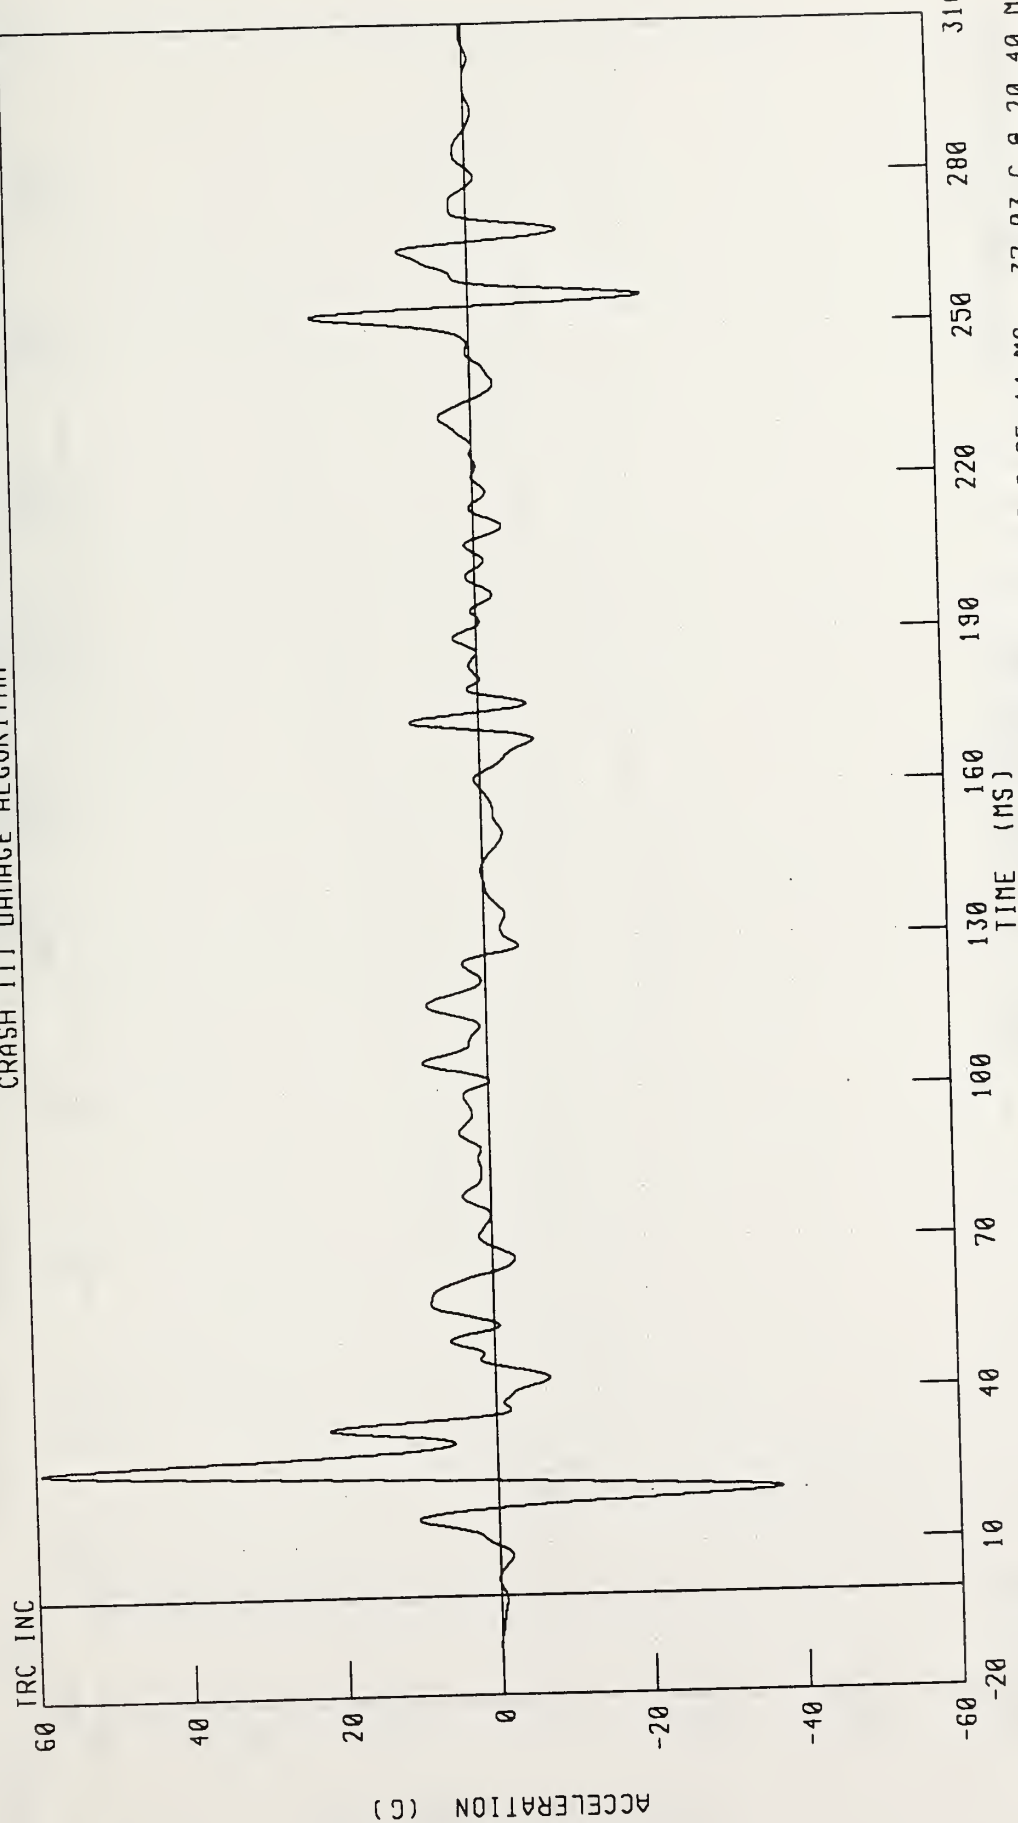
TEST NUMBER 940613-4

1991 CHEVROLET SILVERADO PICKUP TRUCK INTO 50% LEFT OFFSET BARRIER  
VEHICLE CG Z-AXIS ACCELERATION  
CRASH III DAMAGE ALGORITHM

CHANNEL VCGZG1 FILTER CH CLASS 60

PEAK DATA: 59 34 G @ 25 44 MS, -37 03 G @ 20 40 MS

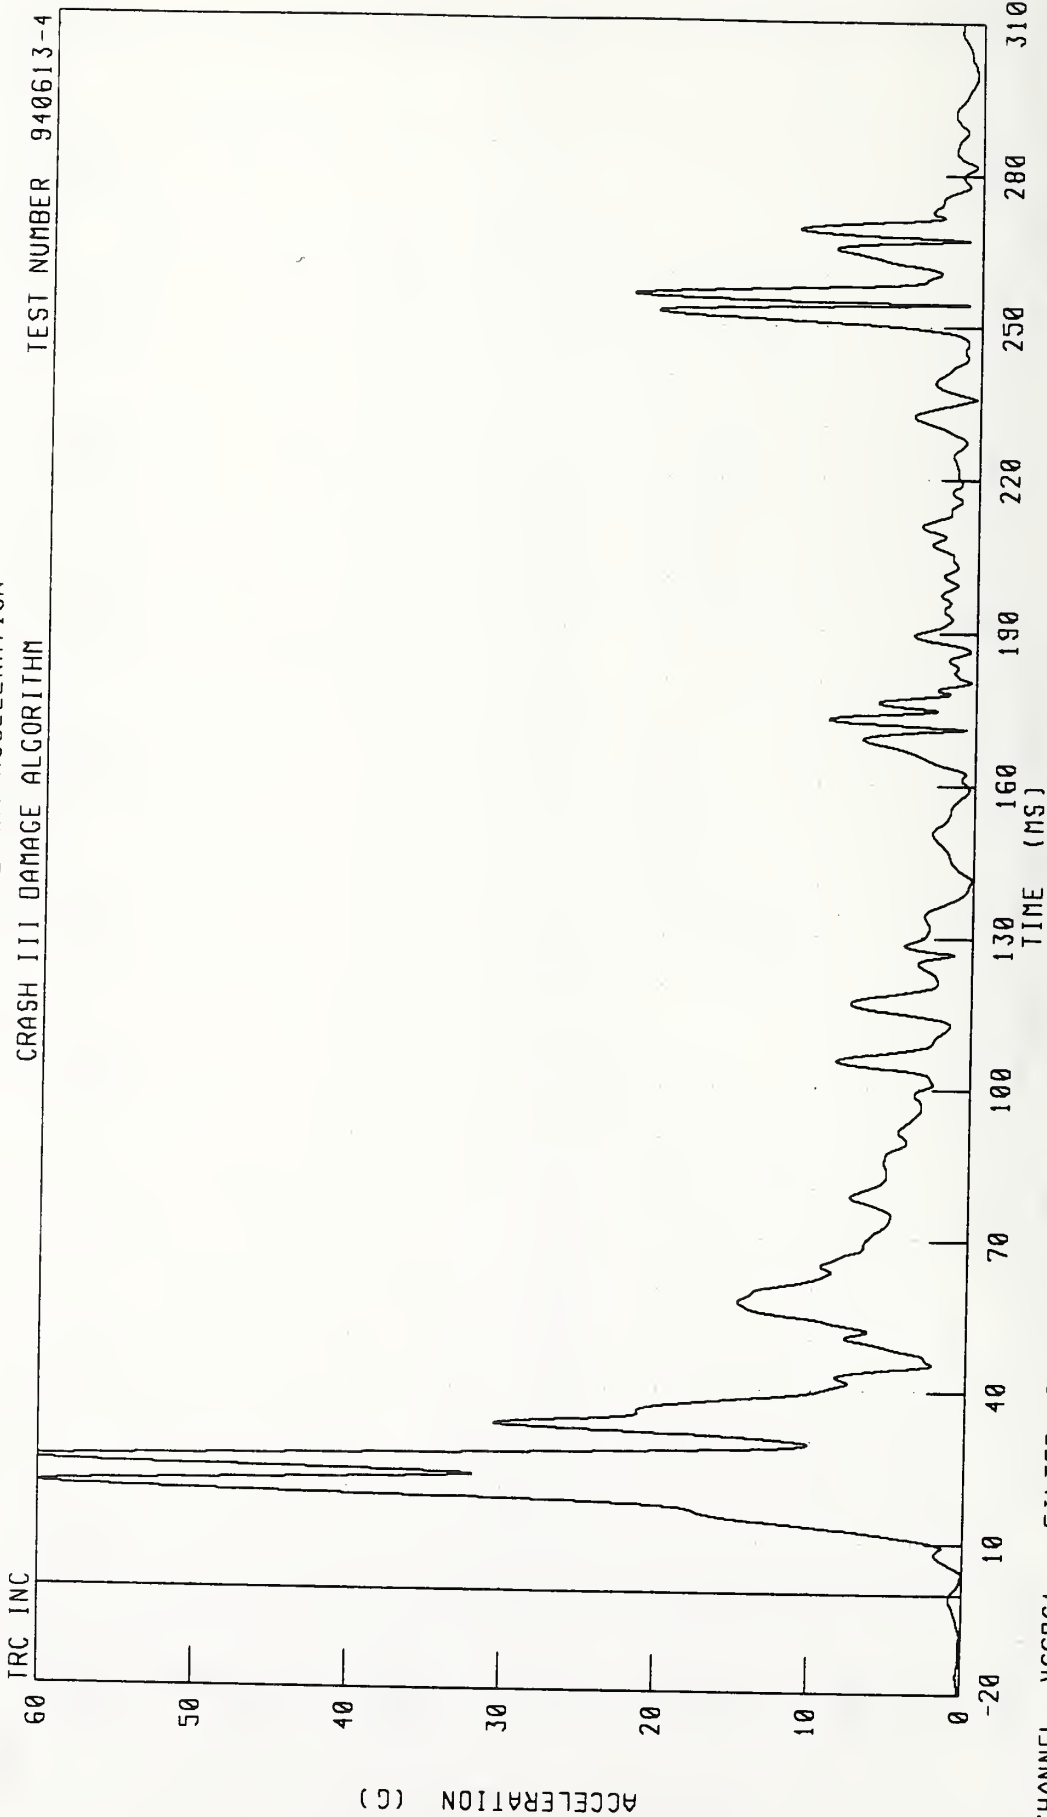
1991 CHEVROLET SILVERADO PICKUP TRUCK INTO 50% LEFT OFFSET BARRIER  
VEHICLE CG RESULTANT ACCELERATION

CHANNEL VCGRG1 FILTER CH CLASS 60

PEAK DATA: 61.48 G @ 25.36 MS; 0.03 G @ 400 MS

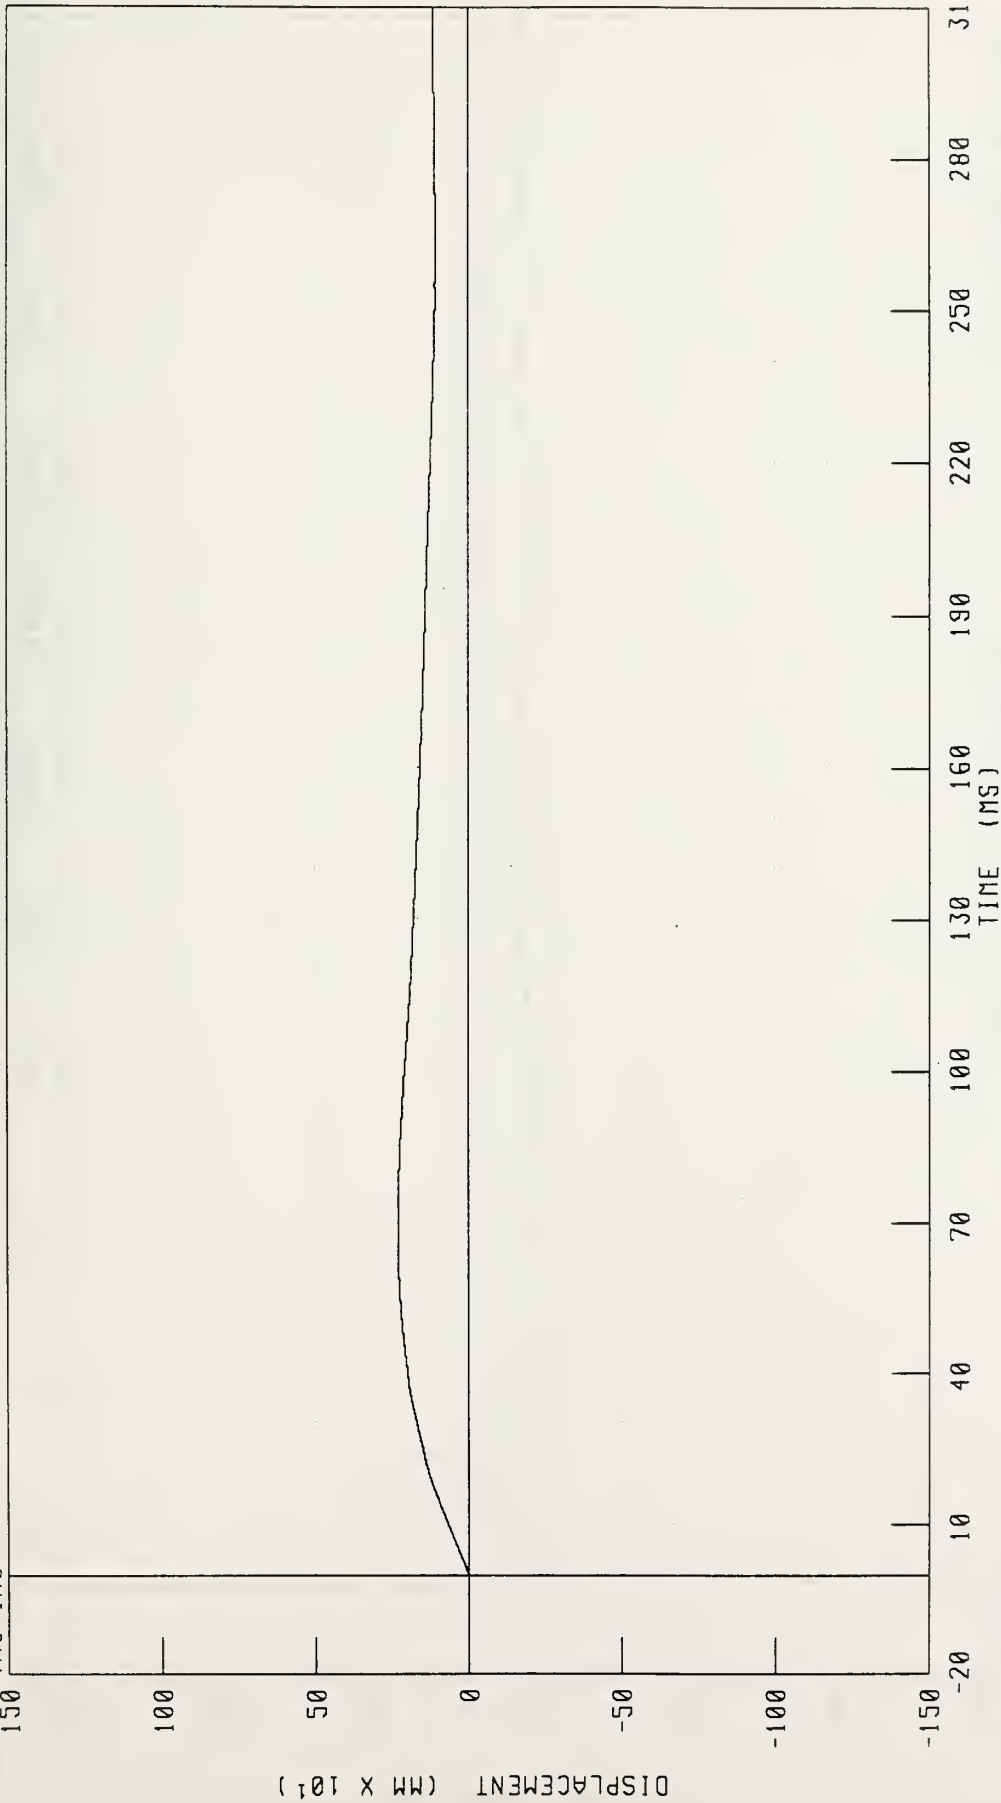
CRASH III DAMAGE ALGORITHM TEST NUMBER 940613-4

1991 CHEVROLET SILVERADO PICKUP TRUCK INTO 50% LEFT OFFSET BARRIER  
LEFT REAR SILL X-AXIS DISPLACEMENT

CHANNEL LRSXD1 FILTER CH CLASS 180

PEAK DATA 229 75 MM @ 68 08 MS, 0 00 MM @ 0 00 MS

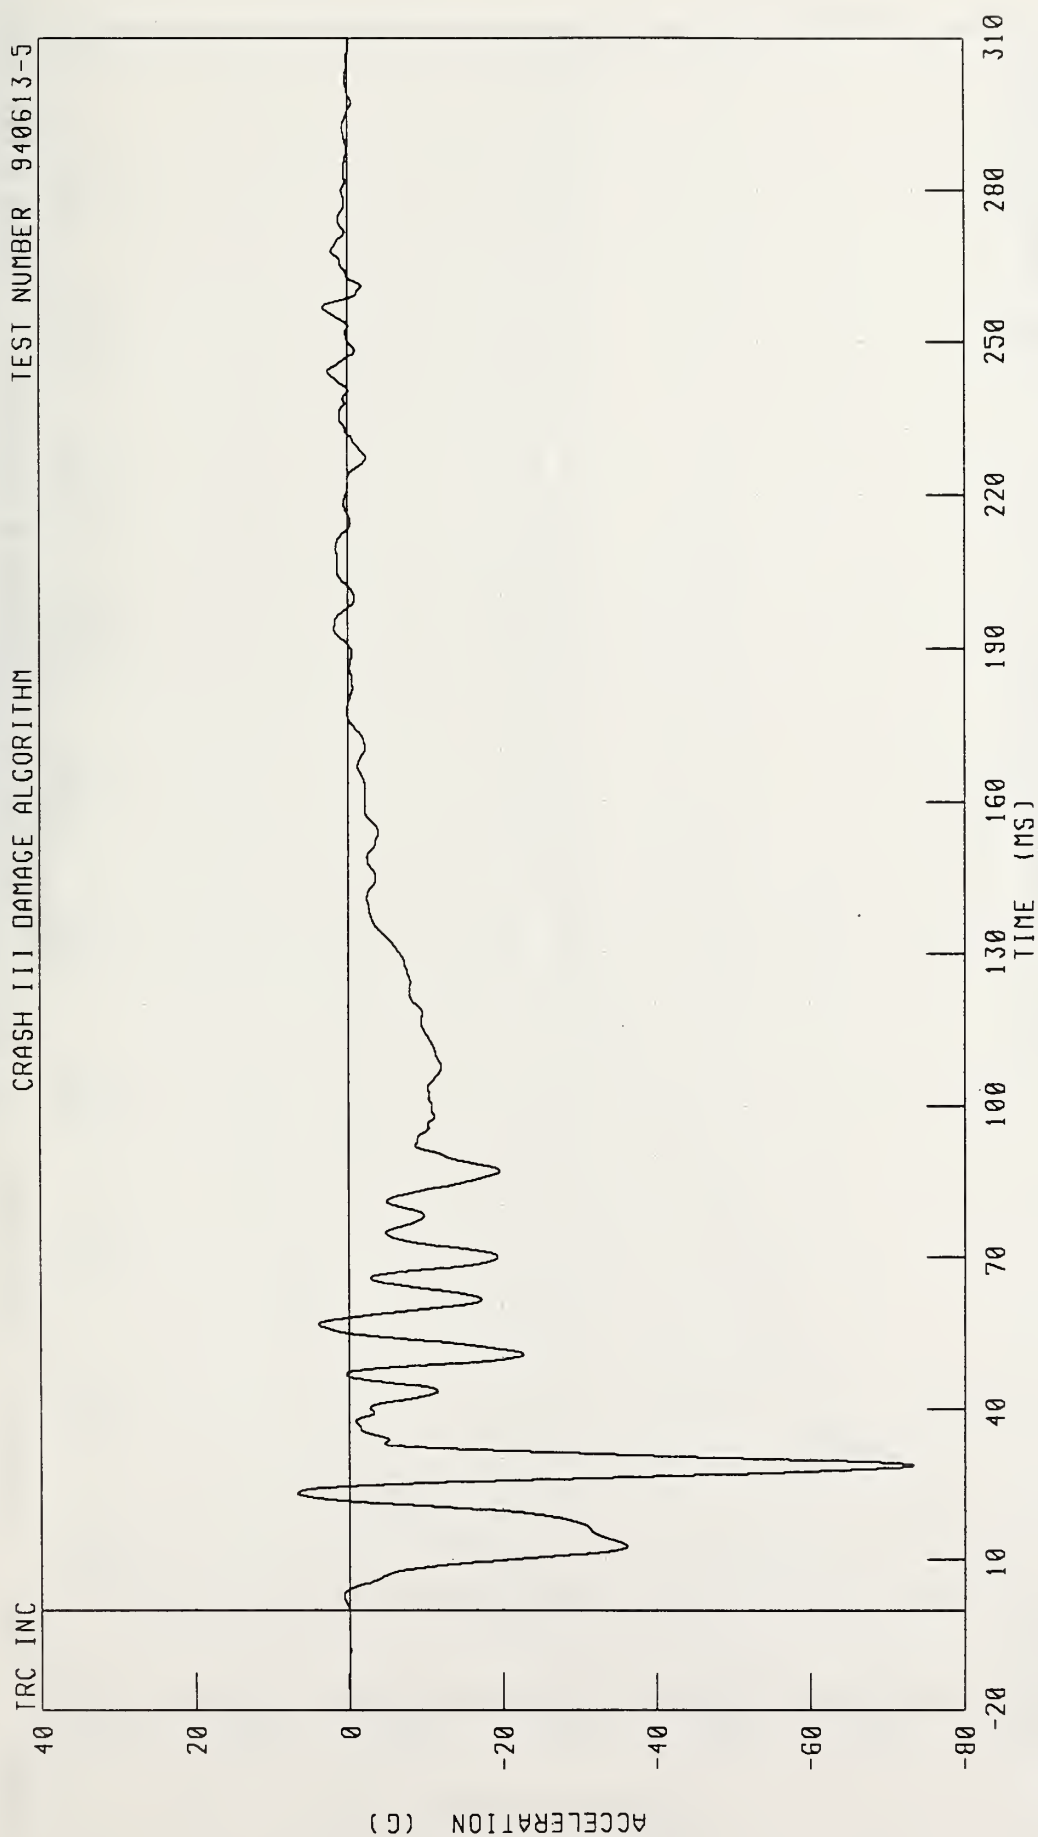
CRASH III DAMAGE ALGORITHM TEST NUMBER 940613-5

CHANNEL VCGXG1 FILTER CH CLASS 60

PEAK DATA 6 74 G @ 23 20 MS, -73 30 G @ 28 88 MS

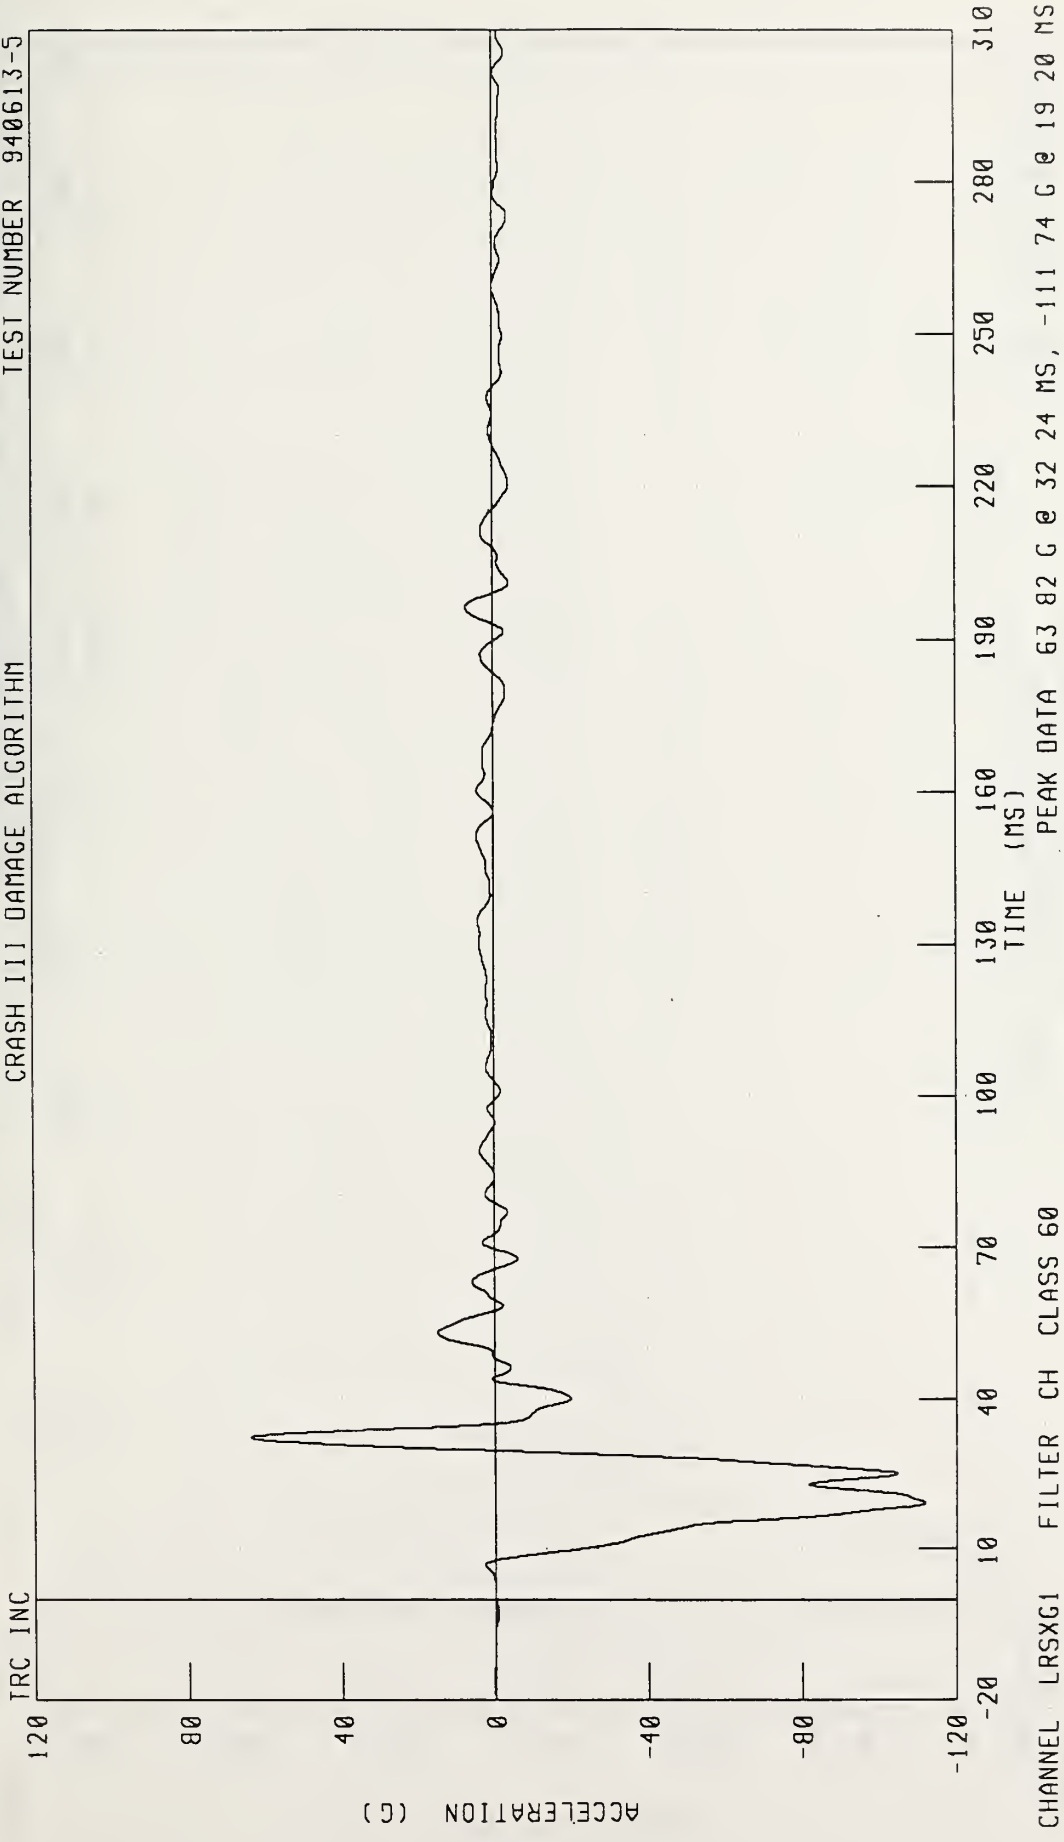
TEST NUMBER 940613-5

1991 CHEVROLET SILVERADO PICKUP TRUCK INTO 50% LEFT OFFSET BARRIER  
LEFT REAR SILL X-AXIS ACCELERATION  
CRASH III DAMAGE ALGORITHM

CHANNEL LRSXG1 FILTER CH CLASS 60 PEAK DATA 63 82 G @ 32 24 MS, -111 74 G @ 19 20 MS

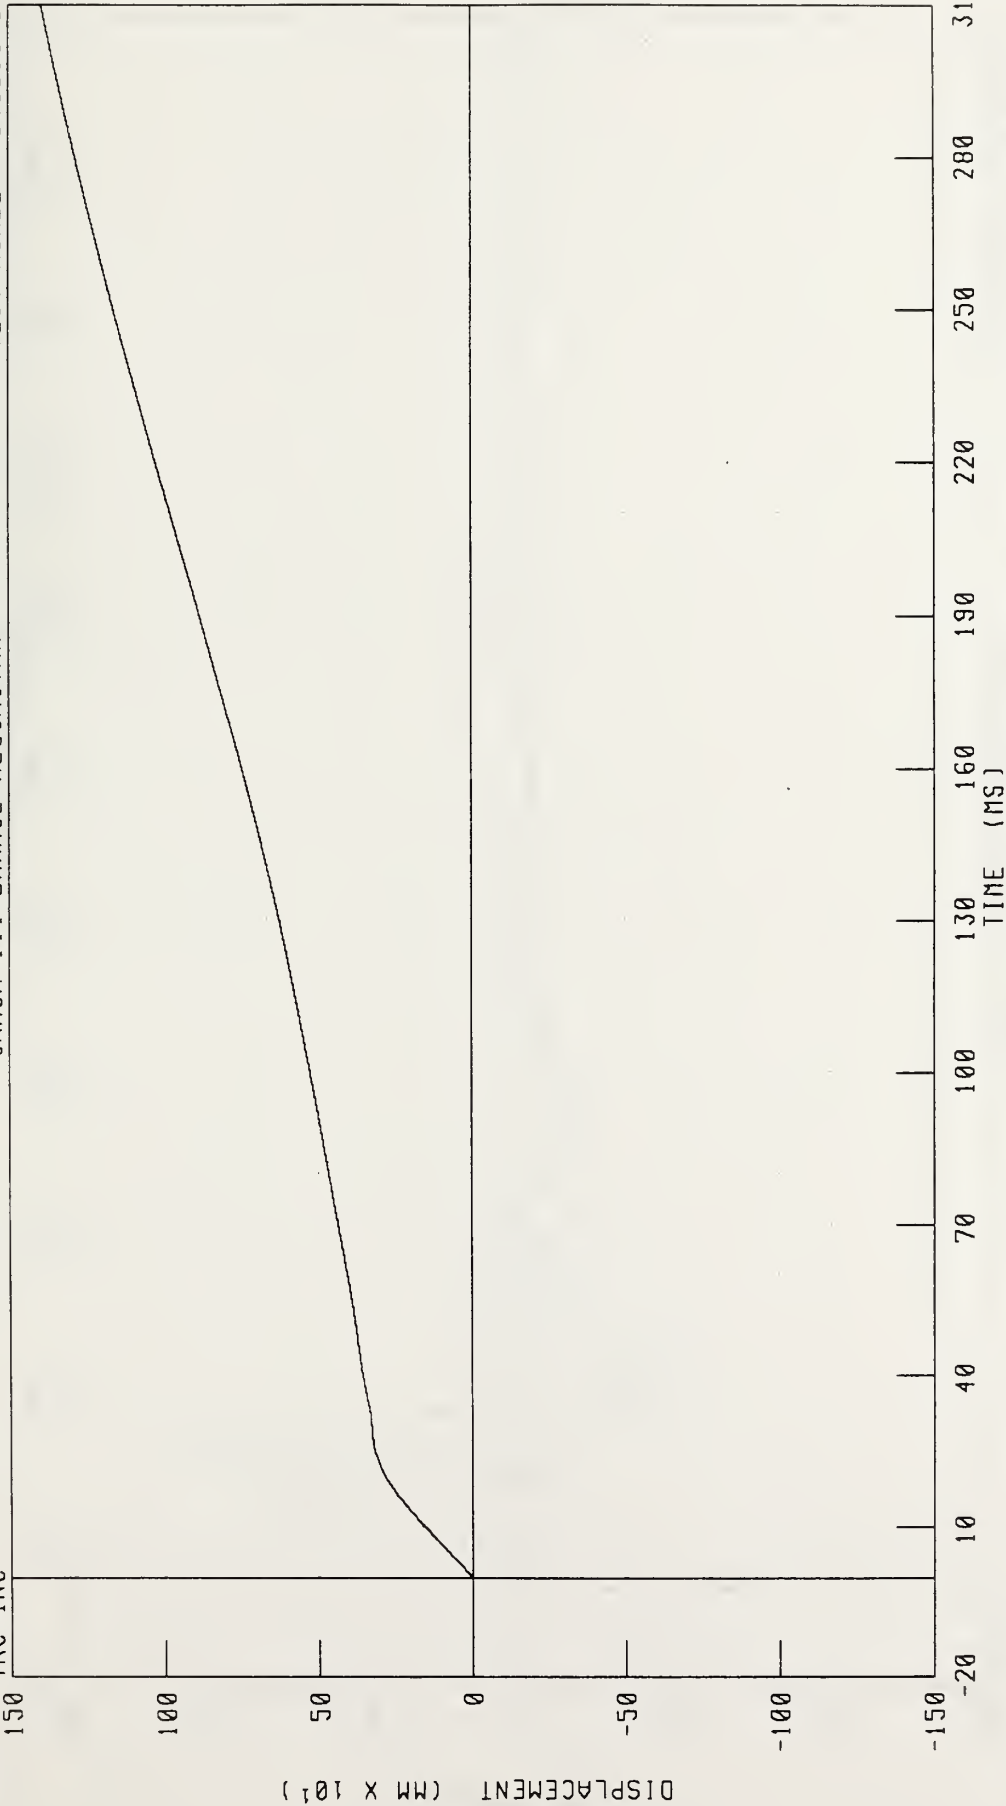
CRASH III DAMAGE ALGORITHM TEST NUMBER 940613-5

CHANNEL LRSX01 FILTER CH CLASS 180

PEAK DATA 1392 46 MM @ 310 00 MS, 0 00 MM @ 0 00 MS

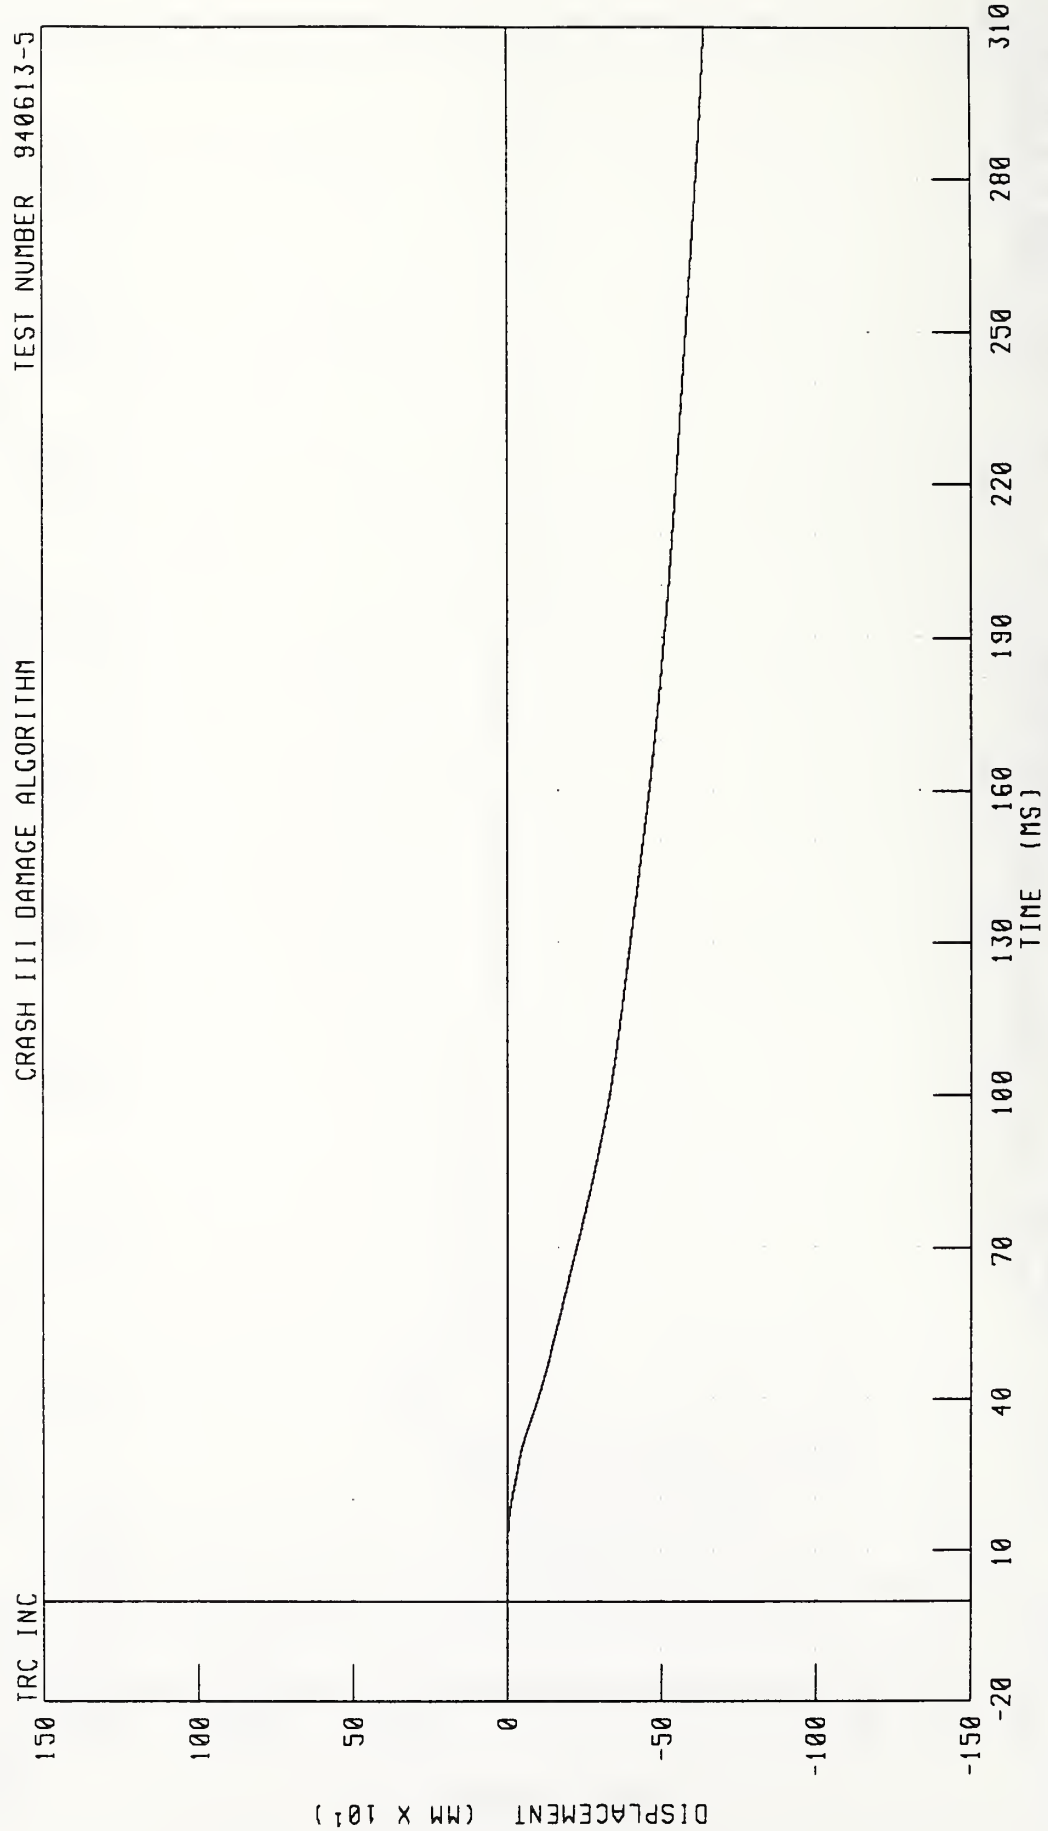
CRASH III DAMAGE ALGORITHM TEST NUMBER 940613-5

CHANNEL RRSYD1 FILTER: CH CLASS 180

PEAK DATA 0 07 MM @ 8 08 MS; -640 23 MM @ 310 00 MS
